MISCELLANEOUS PAPER GL-87-17

CONDITION SURVEY AND PAVER IMPLEMENTATION EIELSON AIR FORCE BASE. ALASKA

Ross A Bentsen

July 1987 Final Report

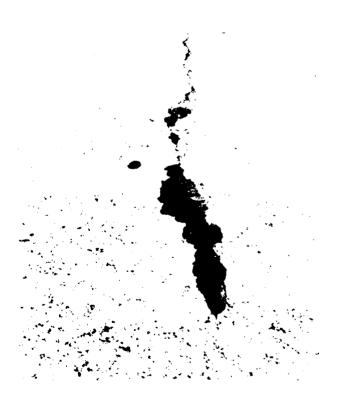
Figure 7. Preoverlay crack sealant, tied ing through low-severity cracking, edge of hunway 14-31, north end

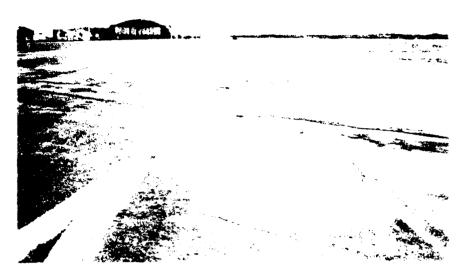
Photo 11. Surface condition showing nigh-severity degressions in Feature T100, Section 2

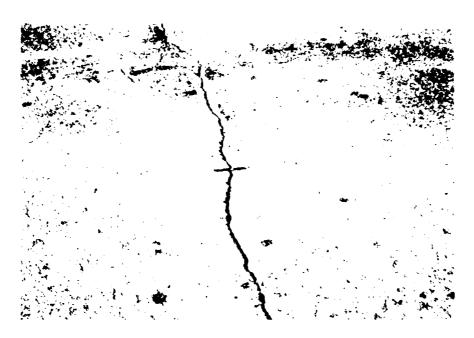
Photo 13. Typical unsealed, low-devenity cracking, main taxiway (T13A)

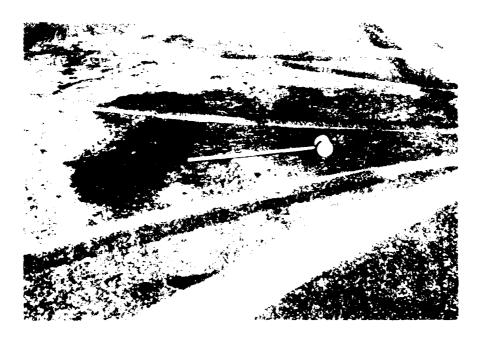
Photo 14. Bleeding, main taxiway (T13A)

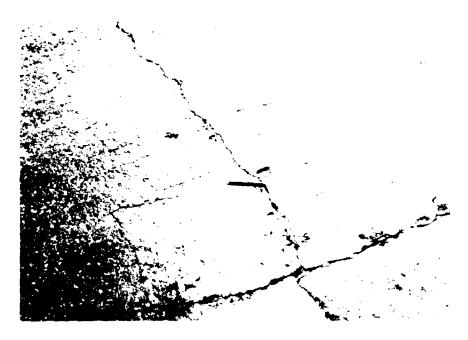
Photo 16. Low-severity cracking and general condition of asphalt surface, Taxiway 4 (T17C)

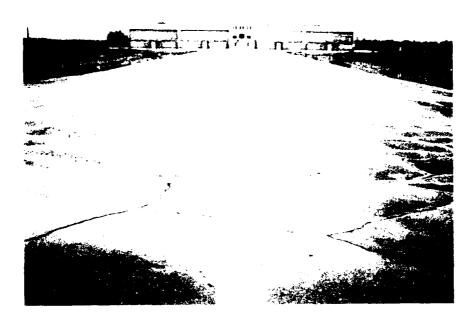
Photo 17. General view of surface cracking, alert area access taxiway (T22A)

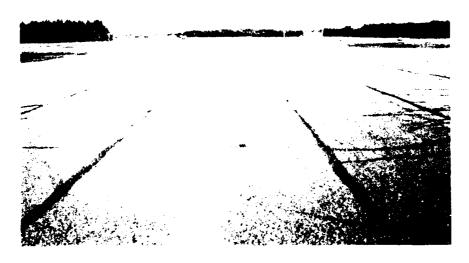
Photo 18. General view of loop taxiway (T23A) showing typical cracking

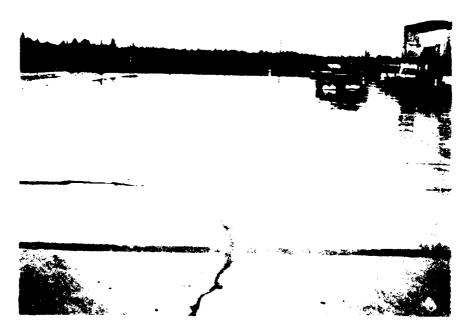
Photo 31. Low-severity shattered slab, alert area apron (A13B)
